**ENVIRONMENTAL SITE ASSESSMENT
FOR THE
EVALUATION OF POTENTIALLY
HAZARDOUS MATERIALS**

*Vacant area
5634 Arthington St.
Houston, Texas 77053*

Prepared for
City of Houston
Building Services Department
P.O. Box 1562
Houston, Texas 77251

Date of the report: 01/04/06

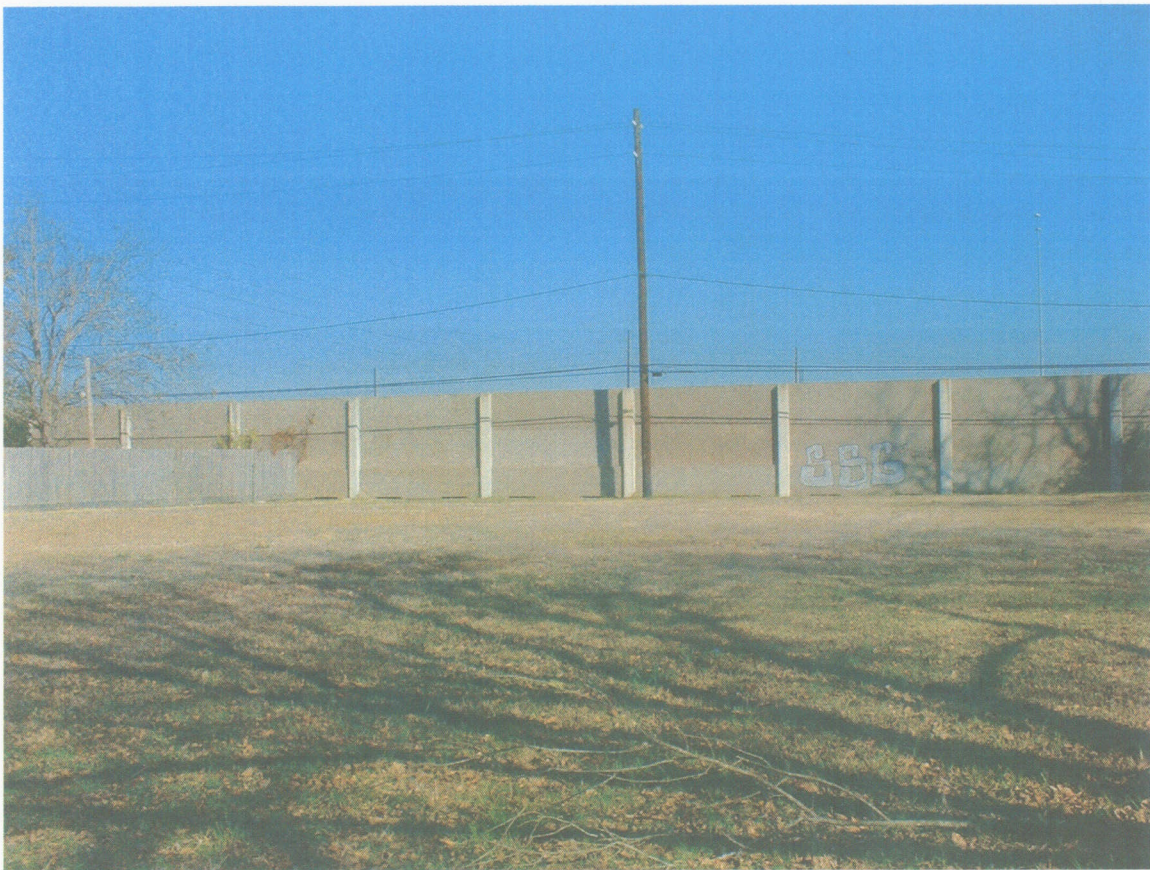
Subject site (vacant land)

The subject property is a vacant area and has 16,800 square feet in area. The site has vacant, grassy areas. Entrance to the site is from Arthington Ave. A small asphalt paved area was found to the south of the site. Rest of the area consists of grass. Utility easement area and a concrete wall are present to the northern boundary of the site. Wooden fences of residential houses are present to the east and west of the site. The property does not have pipeline easements. No other developments or improvements were found at the site.

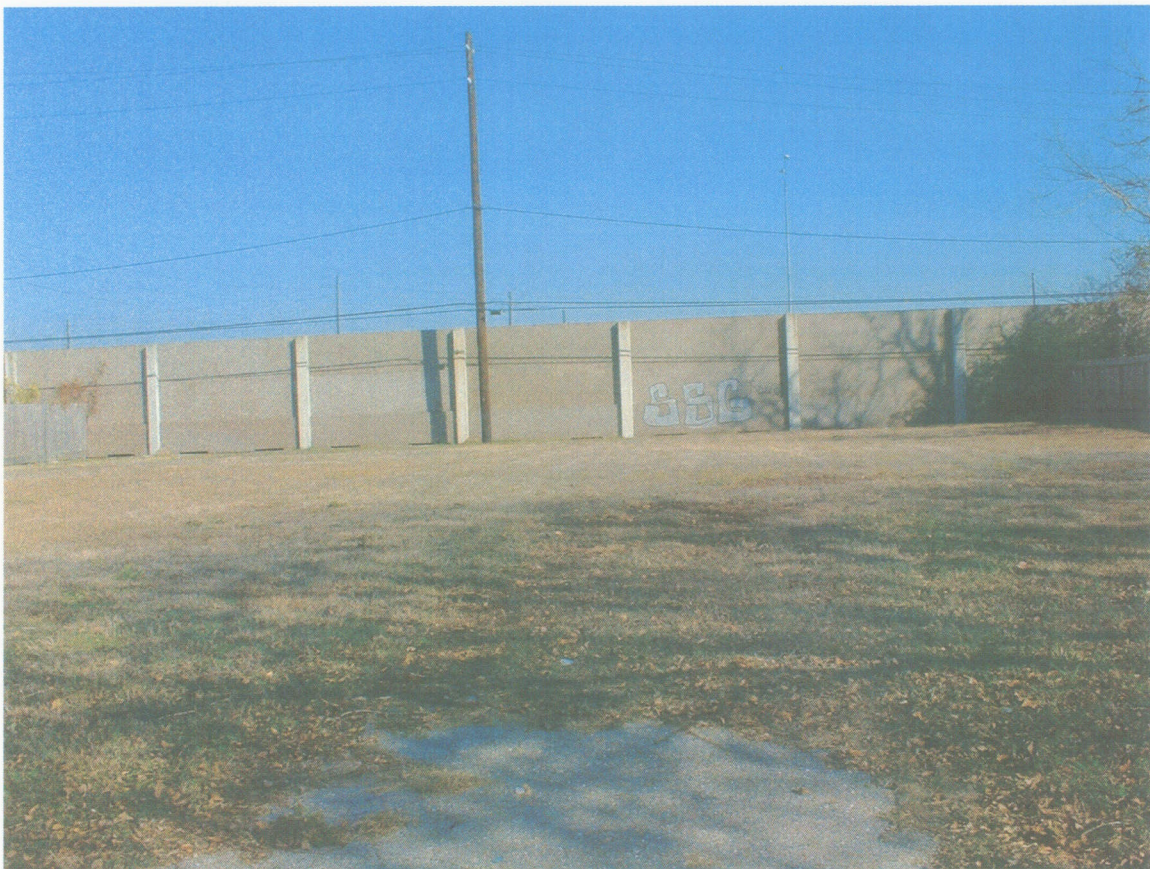
North view of property(vacant land)
